P-6 ADAPTER FOR 6-PORT BOTTOM FEED VALVE INSTALLATION

The R360 P-6 Adapter Assembly is designed to replace old fashioned piston valves, ball valves or flapper vales. Replacing these old style valves will revitalize your In-Floor Cleaning and Circulation System and allow up to 12% more water flow for the same energy dollar. It will also allow for a greater cleaning radius and smoother pressure transition in nearly every application.

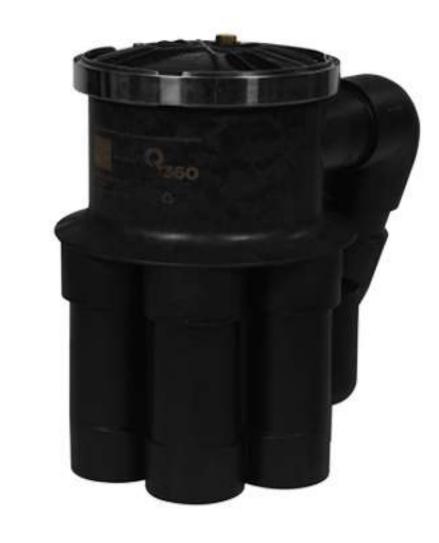
Water level must be below your cut!

It is very important that all seven pipes are cut at the same elevation in order to provide an adequate amount of surface area for a proper glue joint.
